# **Incorrect QNH Selection**

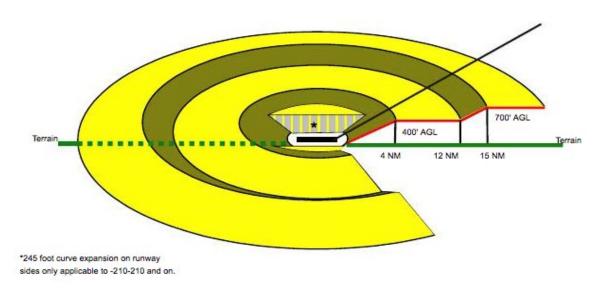
In both cases no aircraft hardware alert was provided to the flight crews, as the respective flight paths were outside the eGPWS activation envelope, either slightly too close to the runway or too high for the system.
