## Czech ALPA warns of potential for taxiway confusion at Prague Ruzyne (LKPR)

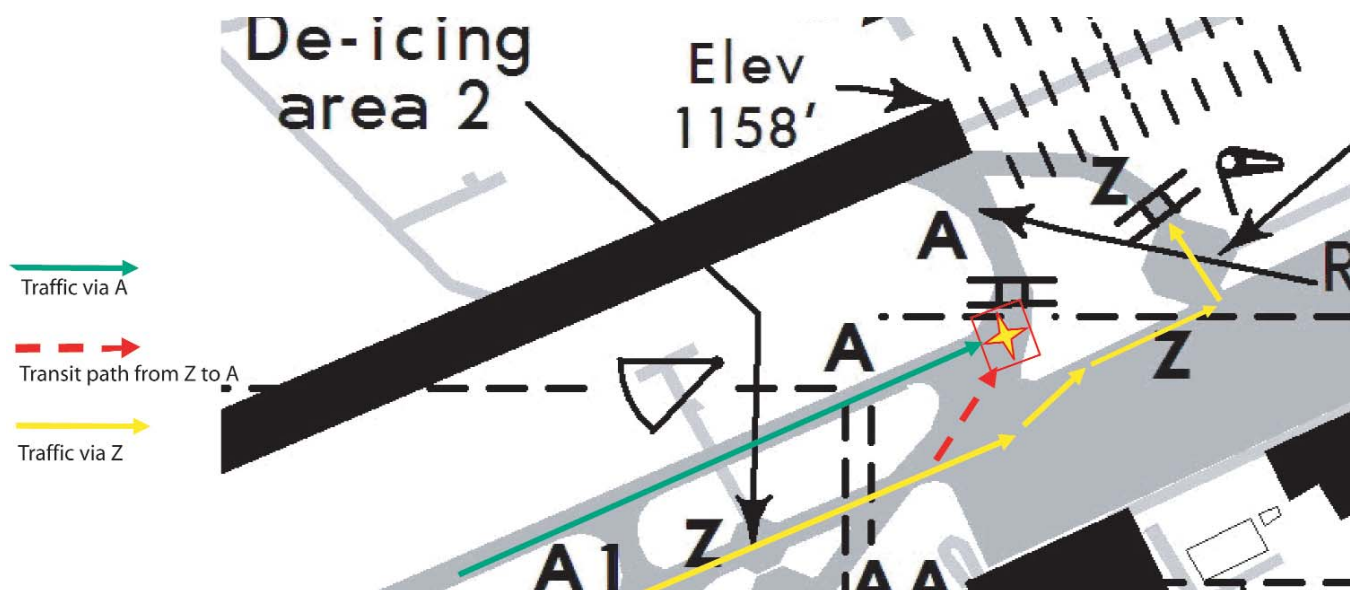
The Czech Air Line Pilot's Association has raised concerns over the potential for taxiway confusion at Prague Ruzyne (LKPR) airport. The concerns centre on the parallel taxiways 'A' and 'Z' which lead toward the holds for runway 24 (see Fig 1).

The intention of ATC is to use these taxiways to sequence departing traffic according to its assigned Standard Instrument Departure route (SID) and/or slot time. However the reality of the current situation is that most traffic is routed via 'A' and, in only a few cases, via 'Z'. The situation is further complicated by the fact that aircraft that are assigned taxiway 'Z' are crossed over to 'A' via an unnamed link taxiway adjacent to the Cargo apron (see yellow star in Fig1).

CZ-ALPA is working with the Local Runway Safety Team (LRST) to develop a standard taxi route system which should mitigate the risk of ground collision and, in addition, campaigning for the link taxiway to be given a designation which should reduce confusion further.

***In the meantime, pilots are urged not to deviate from the taxi route they have been assigned and be extra vigilant in the area of the 'A', 'Z' and 'AA' junctions.***
