Auckland (NZAA) Unplanned Runway Closures

BACKGROUND

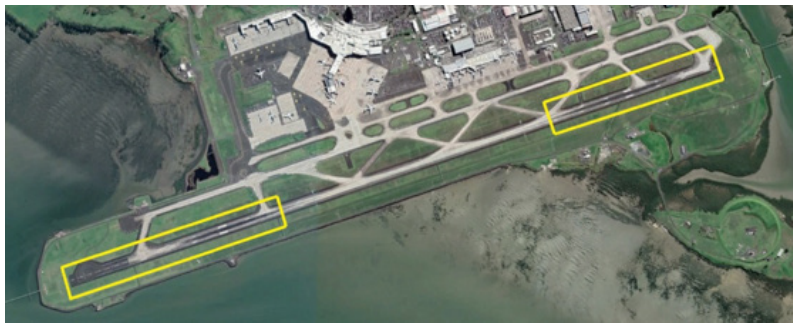
The Auckland Airport runway 23L/05R has been deteriorating over the past few years. The maintenance required to keep the runway surface in a usable condition has increased significantly, however, this has not kept up with the rate at which the runway is deteriorating. As a result, there have been over 15 short notice unplanned runway closures. One, on 24 January 2020, resulted in the runway being closed for 40 minutes and causing the diversion of 9 aircraft, including a wide body international arrival.

With the increasing occurrences of damage to the runway there has been an increased risk of foreign object debris (FOD) damage. Some pieces of broken concrete have been reported up to 30cm by 30cm and 12cm thick.

As these runway closures are not planned and are unable to be forecast, it is suggested that pilots should always carry a technical alternate for Auckland. Alternatively, consider carrying a minimum of 20 minutes extra holding fuel for arrival at Auckland.
